RC
1042
.M38
1990a
c.2

Department
of Transportation
National Highway
Traffic Safety
Administration

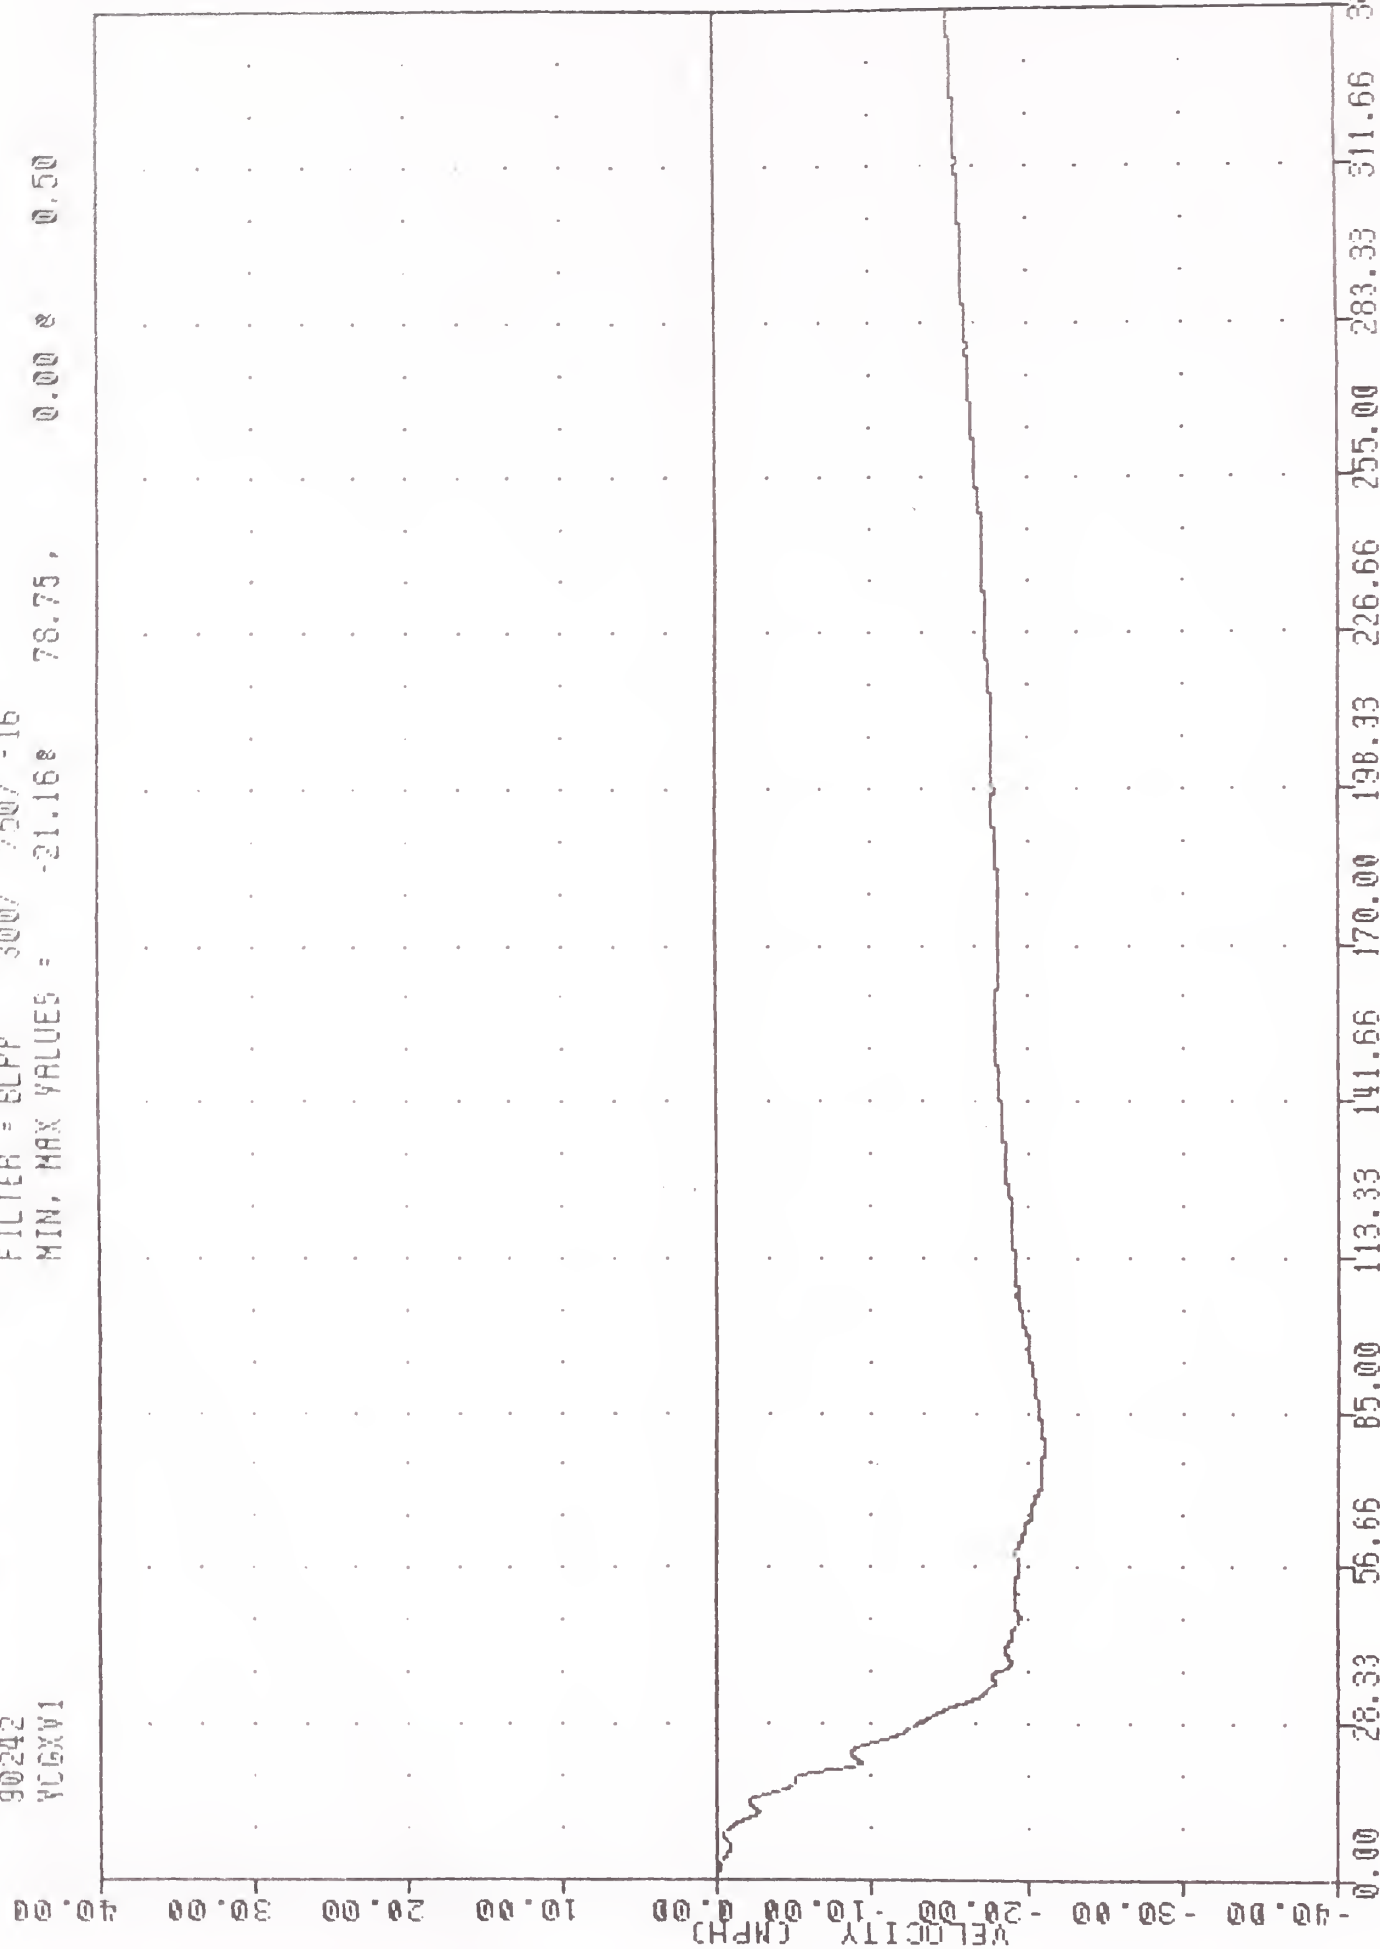
CONTOURED MOVING BARRIER INTO FORD ESCORT AT 39.8 MPH *4
 VEHICLE CG X-AXIS VELOCITY (IMPACT DIRECTION)

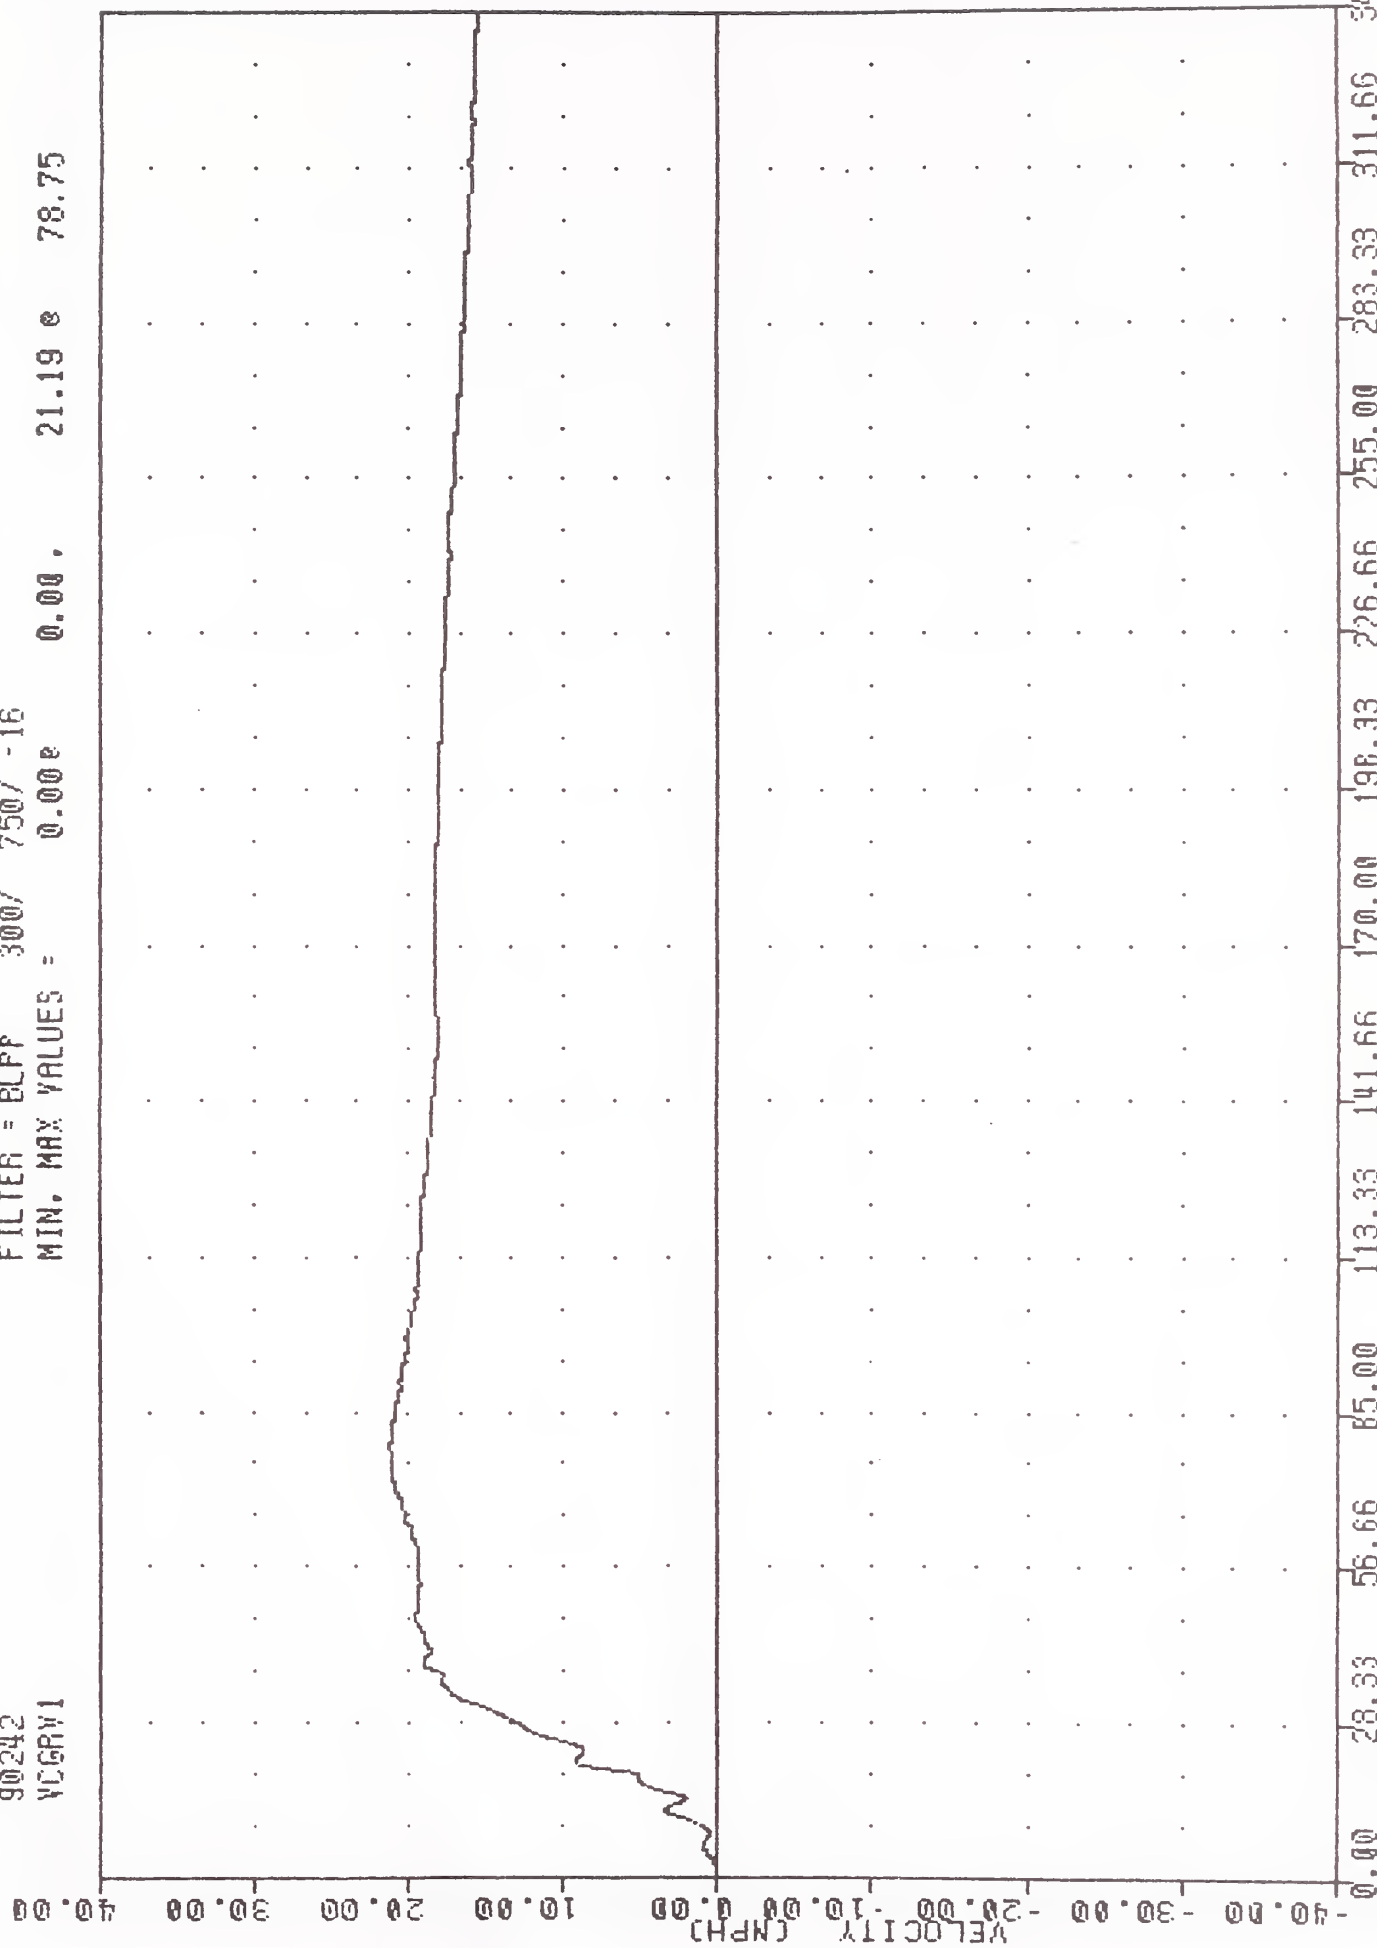
CONTOURED MOVING BARRIER INTO FORD ESCORT AT 39.8 MPH #4
 VEHICLE CG RESULTANT VELOCITY

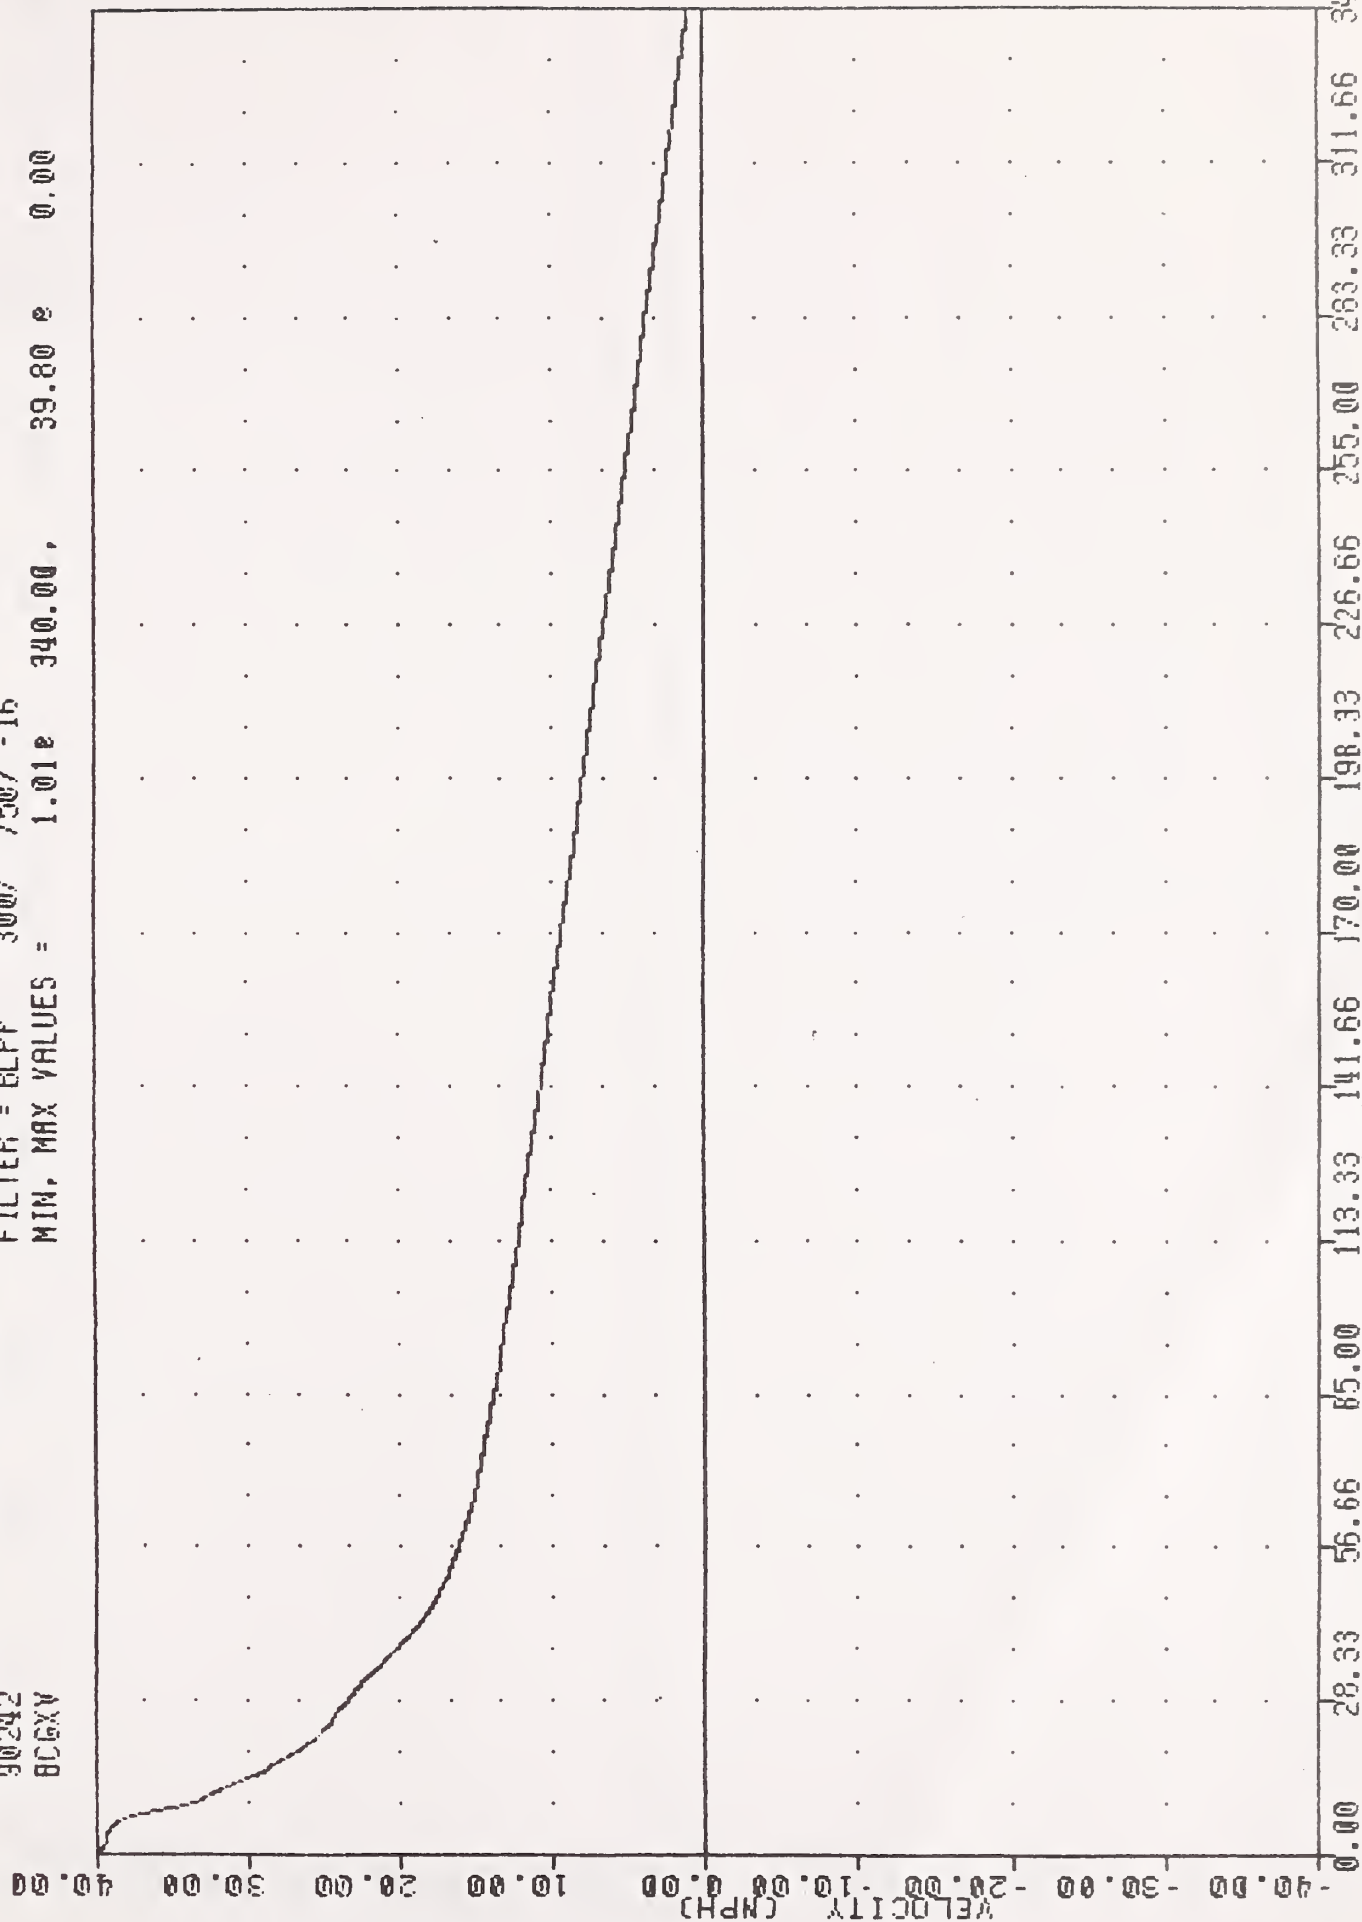
CONTOURED MOVING BARRIER INTO FORD ESCORT AT 39.8 MPH #4
 MOVING BARRIER CENTER OF GRAVITY X-AXIS VELOCITY

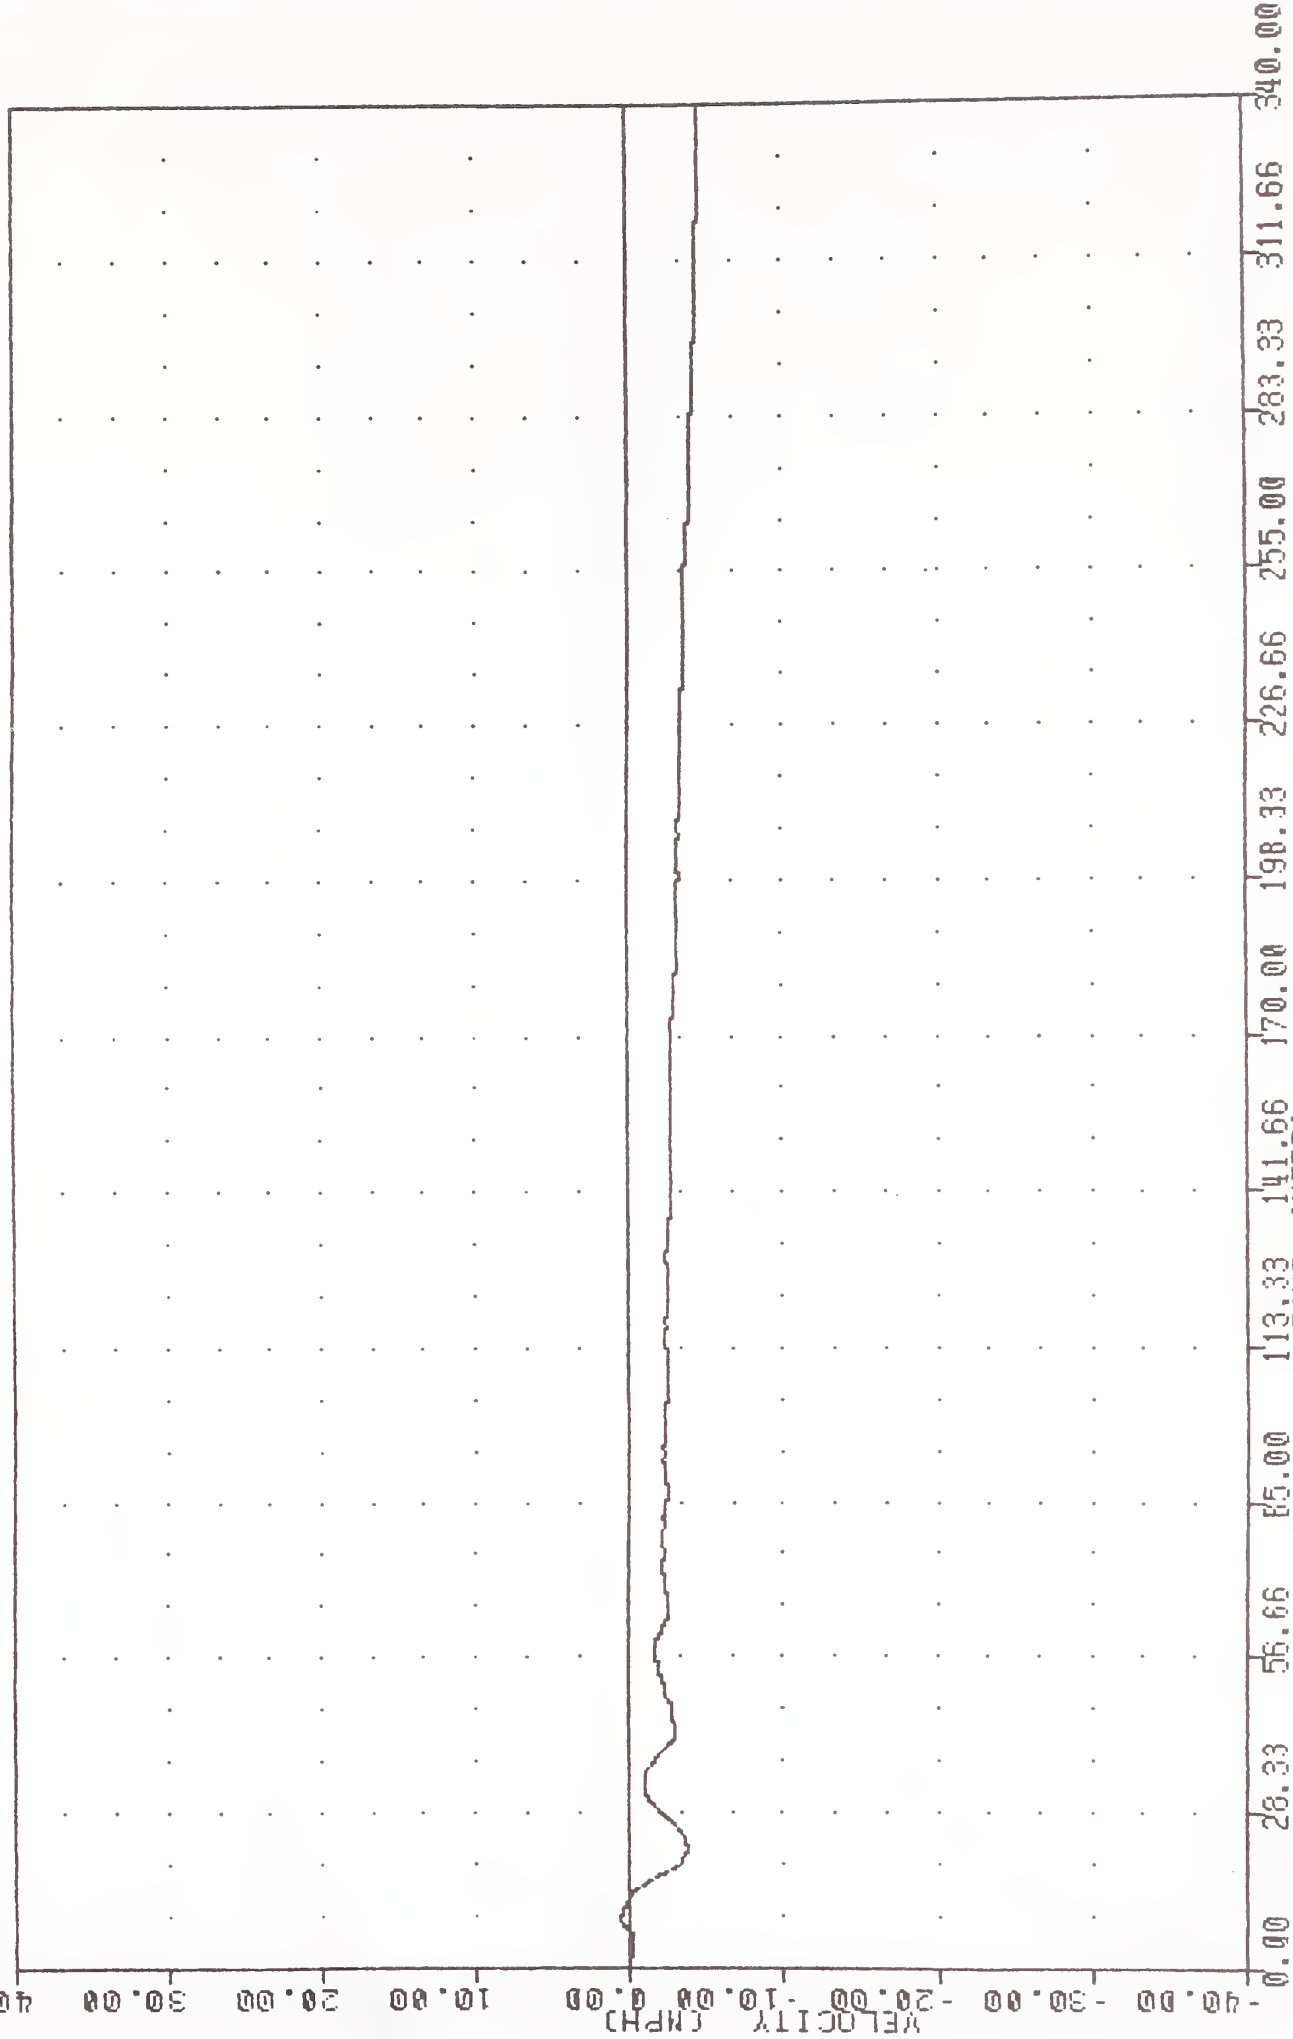
CONTOURED MOVING BARRIER INTO FORD ESCORT AT 39.8 MPH #4
 MOVING BARRIER CENTER OF GRAVITY Y-AXIS VELOCITY

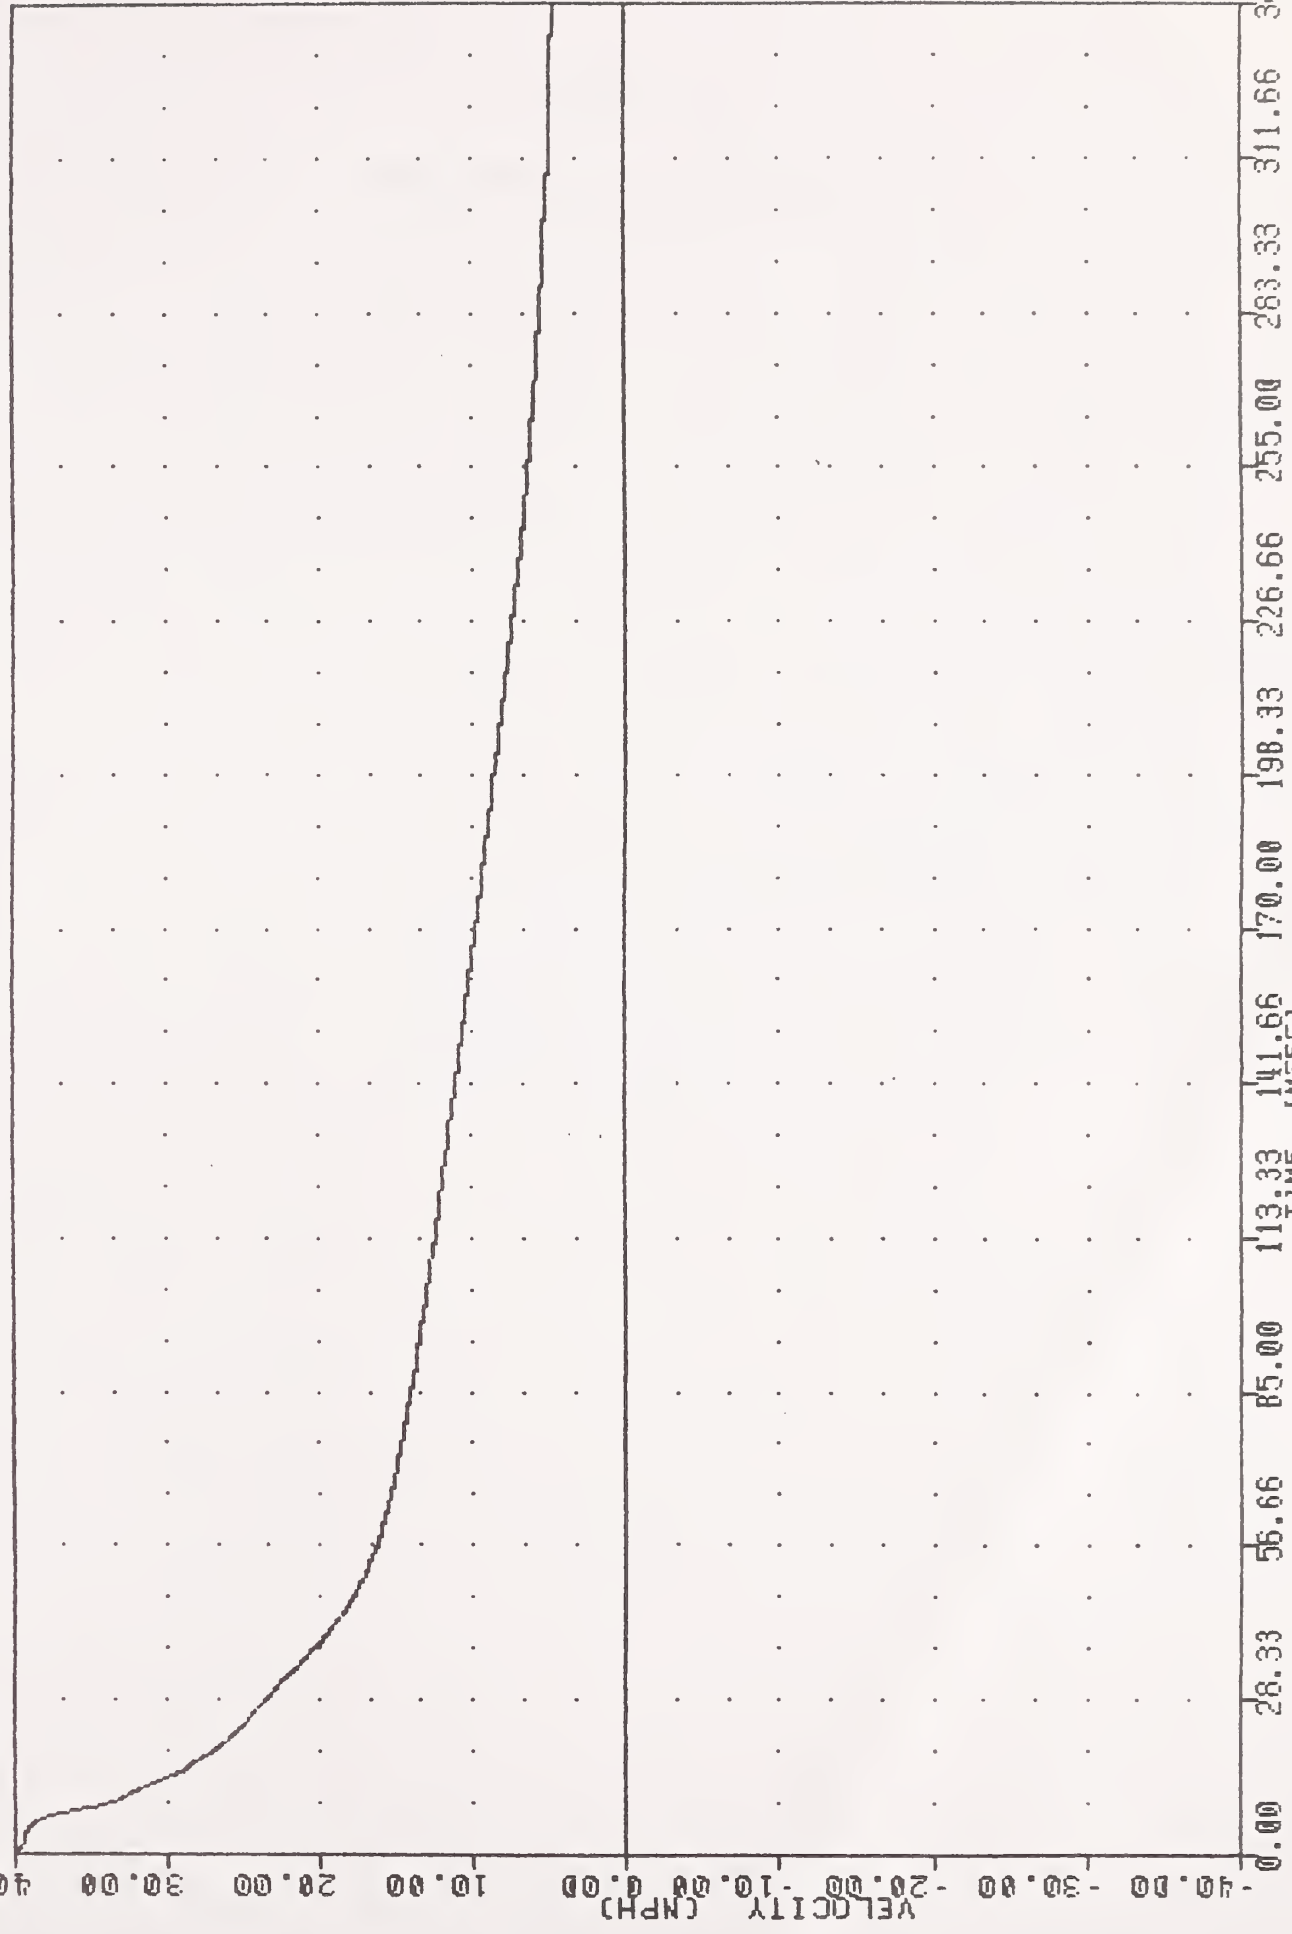
CONTOURED MOVING BARRIER INTO FORD ESCORT AT 39.8 MPH *4
MOVING BARRIER CENTER OF GRAVITY RESULTANT VELOCITY
